## Devil's Slide/Hwy 1 Storm Repair

Daily Updates from Bijan Sartipi

**Daily Update**  
July 17

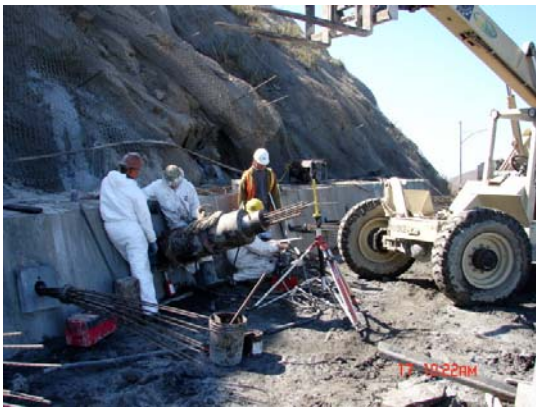
- Level 'B' (lower level ocean side) – Tie back stressing is now complete for this level.
- Level 'D' (upper level cliff side) – Tie back installation now complete at this level. 33 of 33 now installed. Cable stressing continued. Work started to remove the temporary bench.

Stressing cables at level D

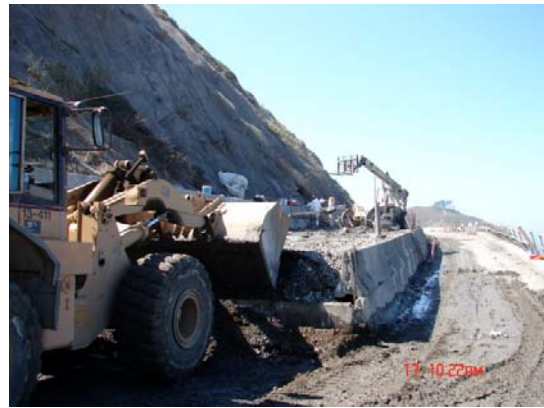
Removing the temporary bench

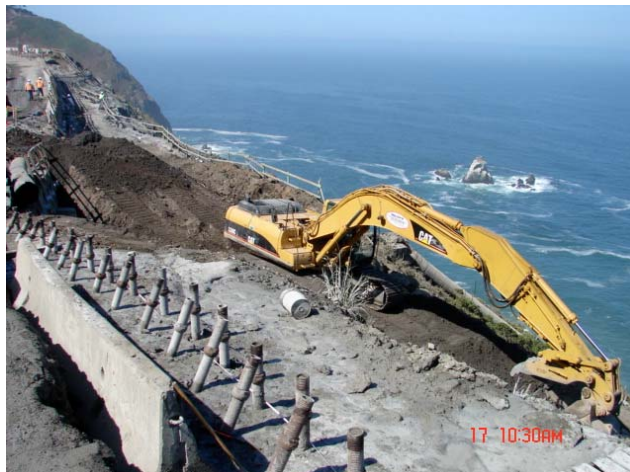
- Drilling and driving steel piles was completed today. Due to interference with a drainage pipe, one micro pile was omitted for a total of 98 installed. A concrete cap will now be cast over the tops of the micropiles.

Micropiles with drain backfilling work in the background

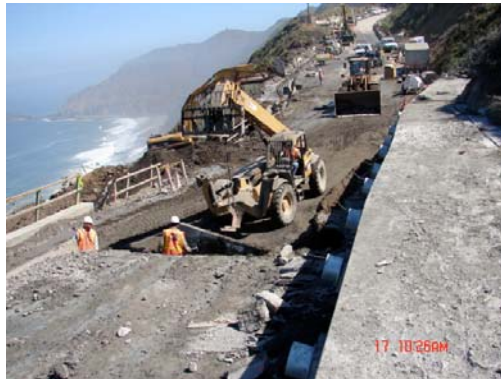
- Surface drain work continued today.

Trenching for drainage pipe under the road bed

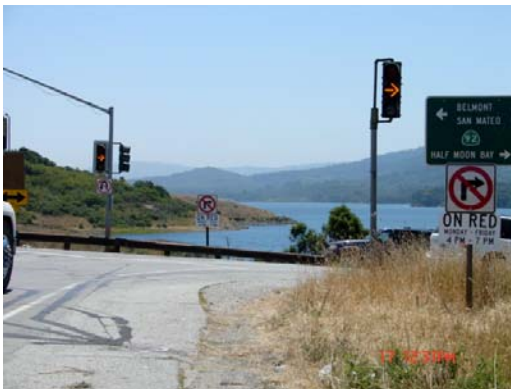
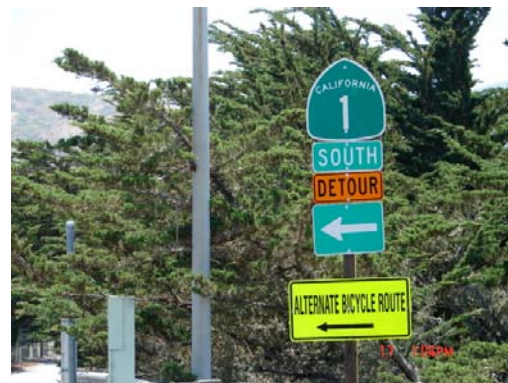
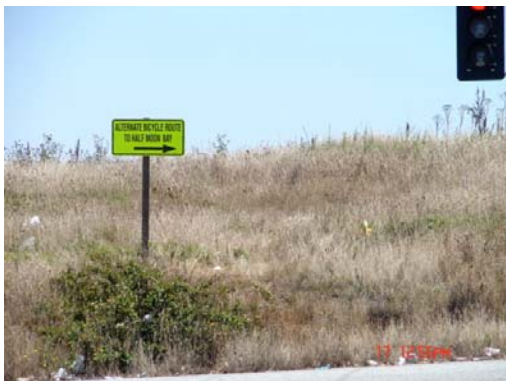
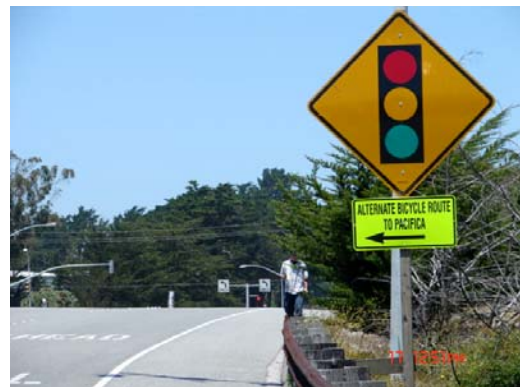
- A 'No Right Turn on Red' is now installed at the junction of Highways 35 and 92. The temporary restriction is in effect Monday to Friday, 4 PM to 7 PM. This measure was implemented in response to congestion during the evening commute west to Half Moon Bay. Bicycle detour signs now installed at various locations. See examples below.
